Total Land Subsidence in Western Metropolitan Phoenix, Maricopa County
Based on Radarsat-2 Satellite Interferometric Synthetic Aperture Radar (InSAR) Data
Time Period of Analysis: 1.0 Years 05/03/2020 To 04/11/2021

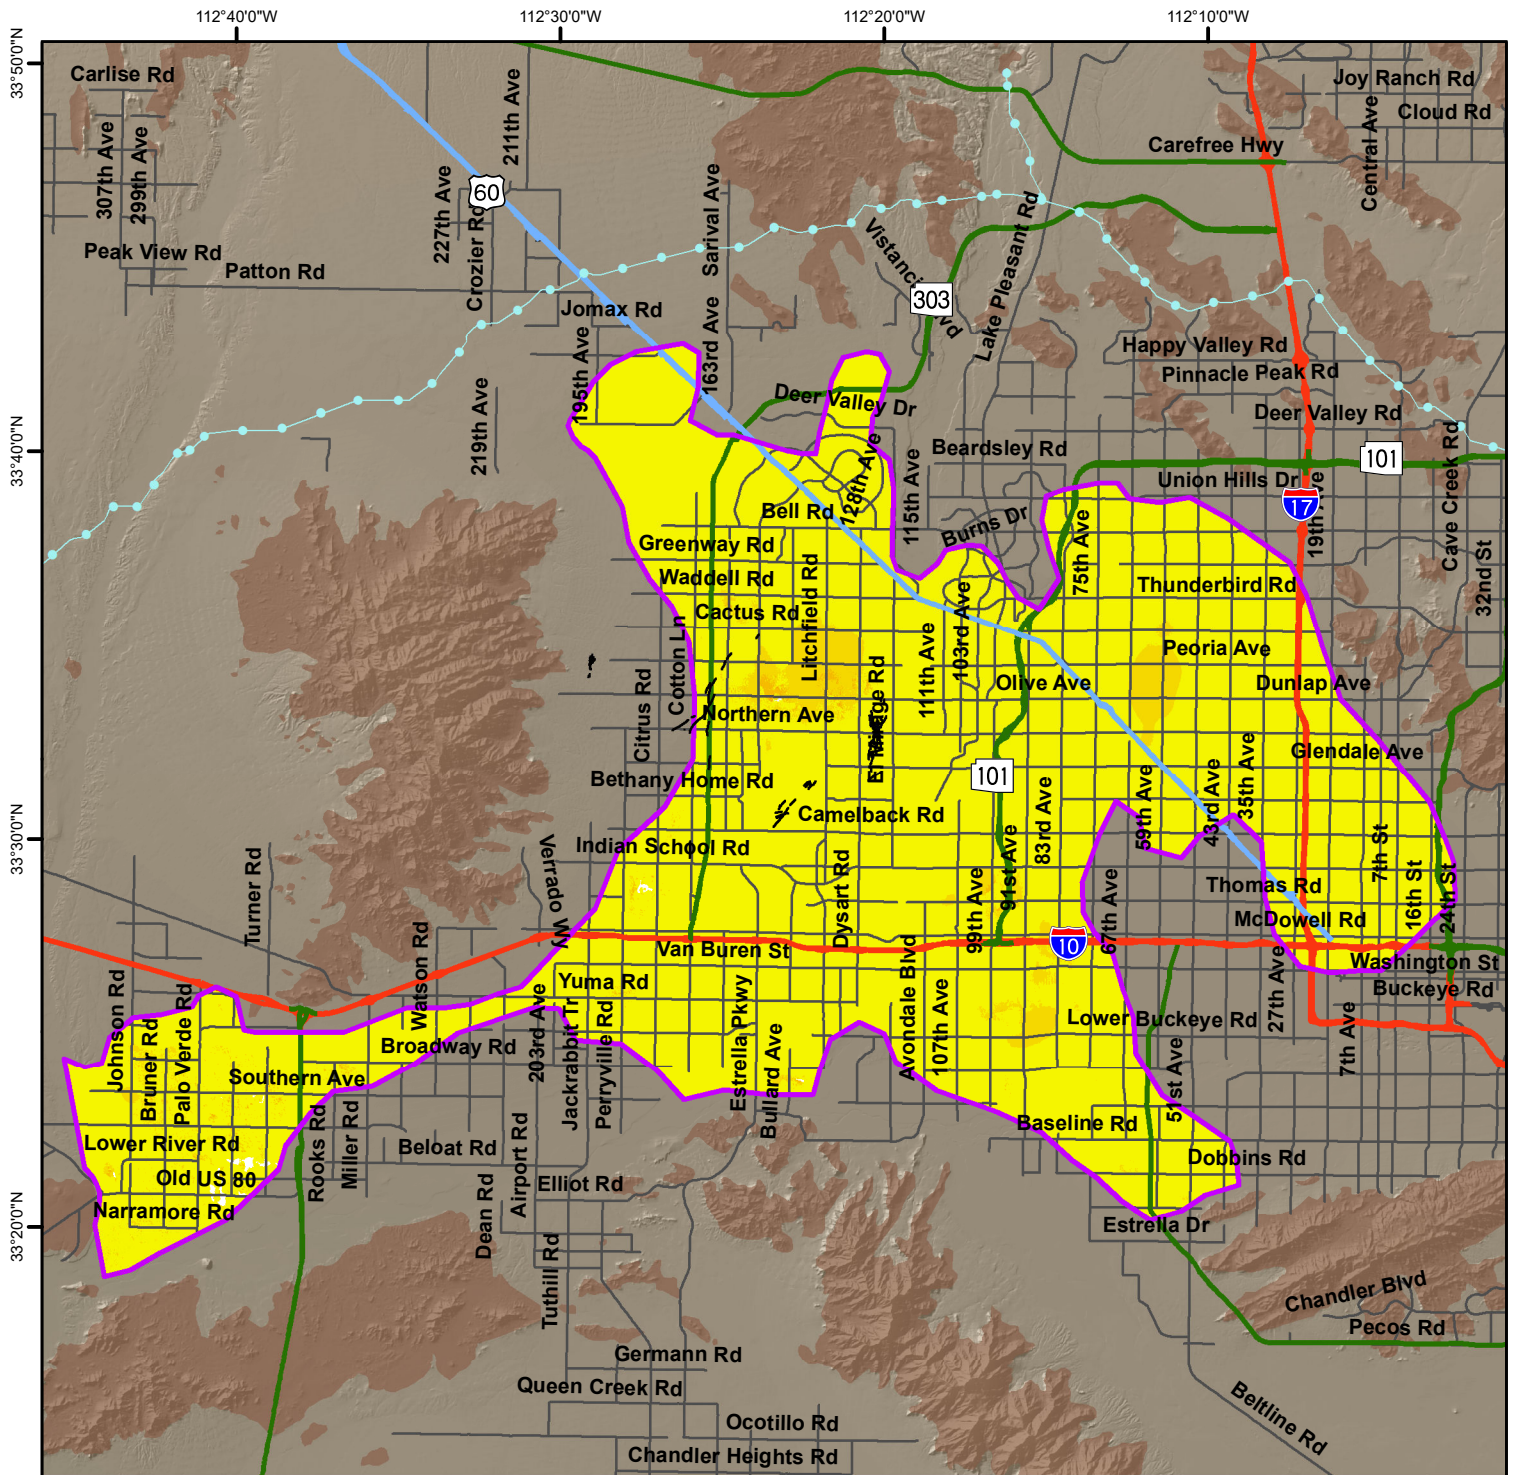
Decorrelation (white areas) are areas where the phase of the received satellite signal changed between satellite passes, causing the data to be unusable. This occurs in areas where the land surface has been disturbed (i.e. bodies of water, snow, agriculture areas, areas of development, etc).
